# TASKER MILLWARD SCHOOL

## KEY FACTS

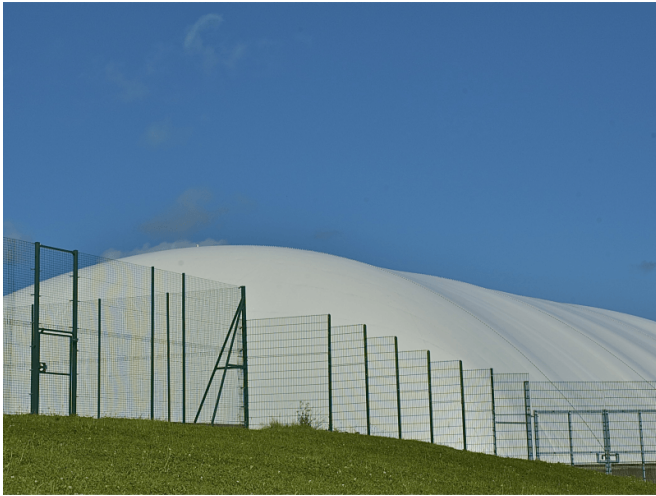
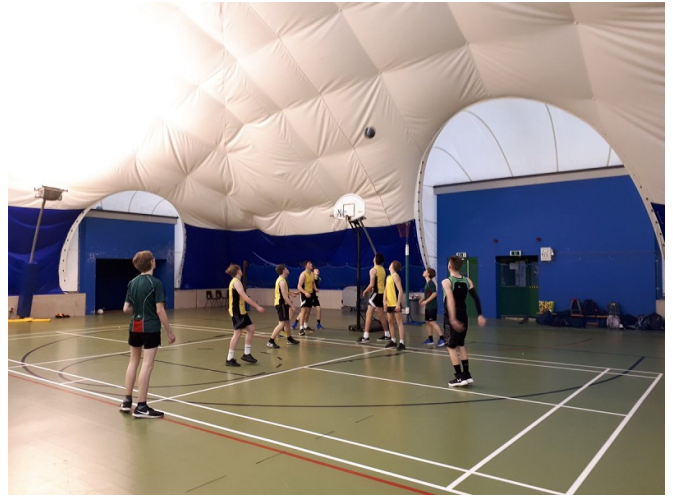
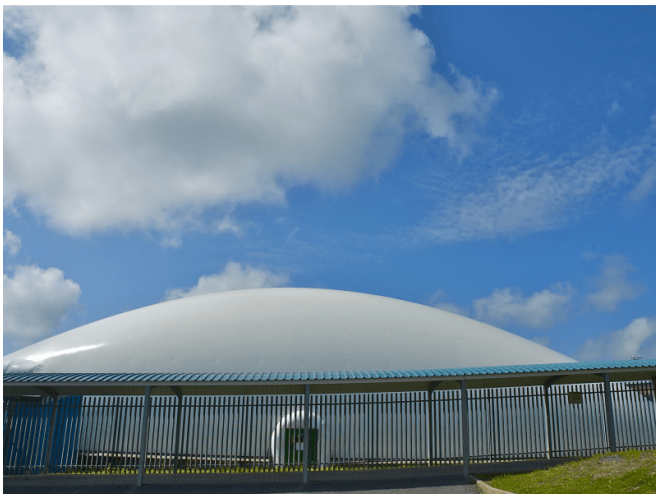
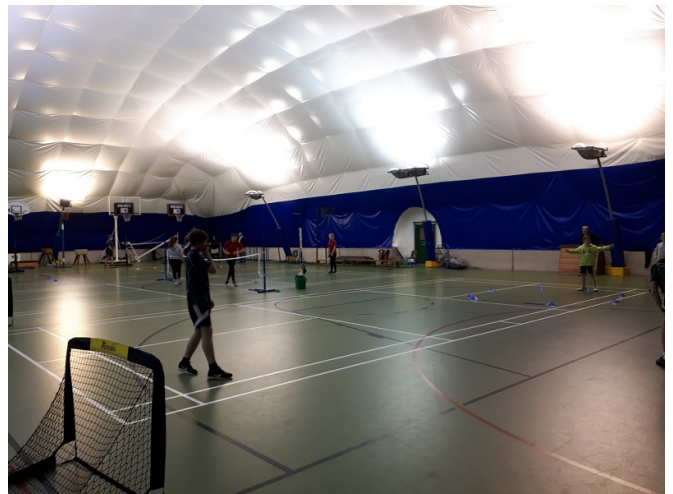
The outer dome fabric is a Type 3 PVC from [Mehler Texnologies](#). The PVDF top lacquer gives excellent protection and makes for easier cleaning and maintenance. The inner lining is a Type 1 650gsm PVC from Mehler. The lower 3m is in a constrasting blue whilst the remainder is white which helps to reflect the light within.

As a specialist contractor, J & J Carter were able to design, manufacture and install a sustainable replacement membrane within a short time frame. Starting with the site survey, J & J Carter took full design responsibility. Due to the sheer size of the dome, it was fabricated off-site in manageable sections with each section site jointed to its neighbouring section with a mechanical joint. The total weight of the membrane was 6.5 tonnes, which had to be inflated to the required pre-stress and form.
